**KMX7* New bayonet design
December 2021**

Description: KMX7 bayonet design change to improve bowl retention in the pedestal.

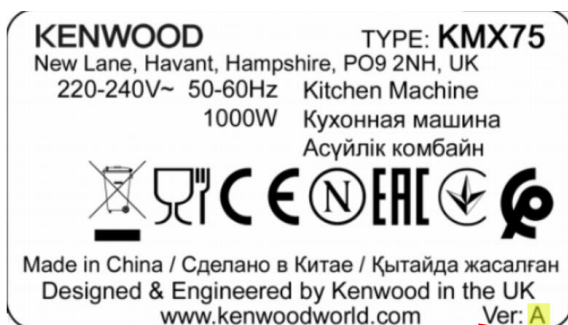
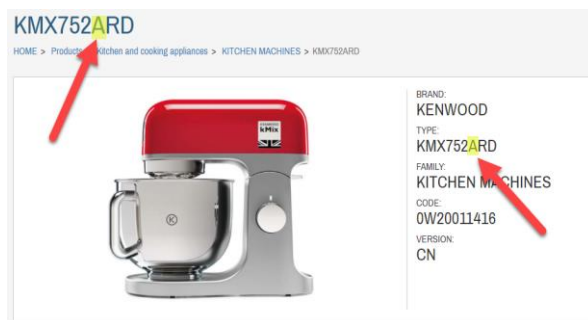
Identification: The KMX7* finished goods with the old bayonet design are discontinued from **21D14**. Finished goods manufactured from date code **21D14** have the new bayonet design. The new bayonet design is indicated by a letter 'A' on the product's label and product model number:

Service repairs: The new and old bayonet types are not interchangeable. When a single part (plastic ring, bowl or bowl socket) is replaced, the other components must be matched.

Example: When a customer has a product date coded **pre-21D14** and orders a **new bowl**, the bowl bayonet socket **AS00002703** must be replaced as well.
